NAAMS LOCATING PINS

HARDNESS TESTING

Developed by: The MISUMI Automotive Business Development Team
06.21.2018

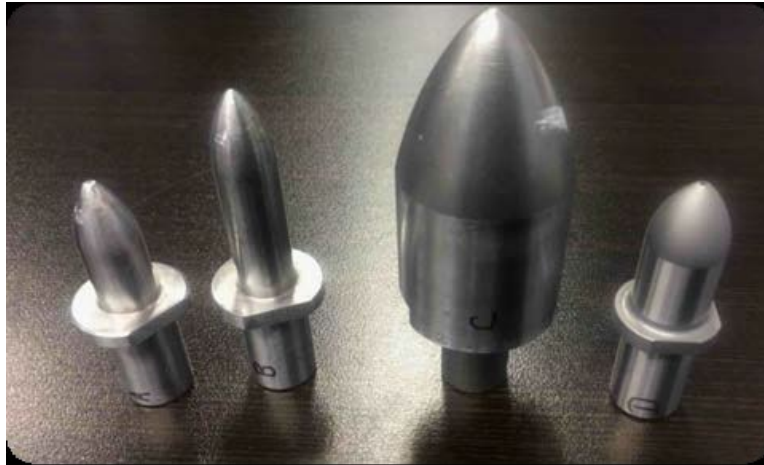
Sample Identification

From left to right: 1-A, 2-B, 3-C, and 4-D

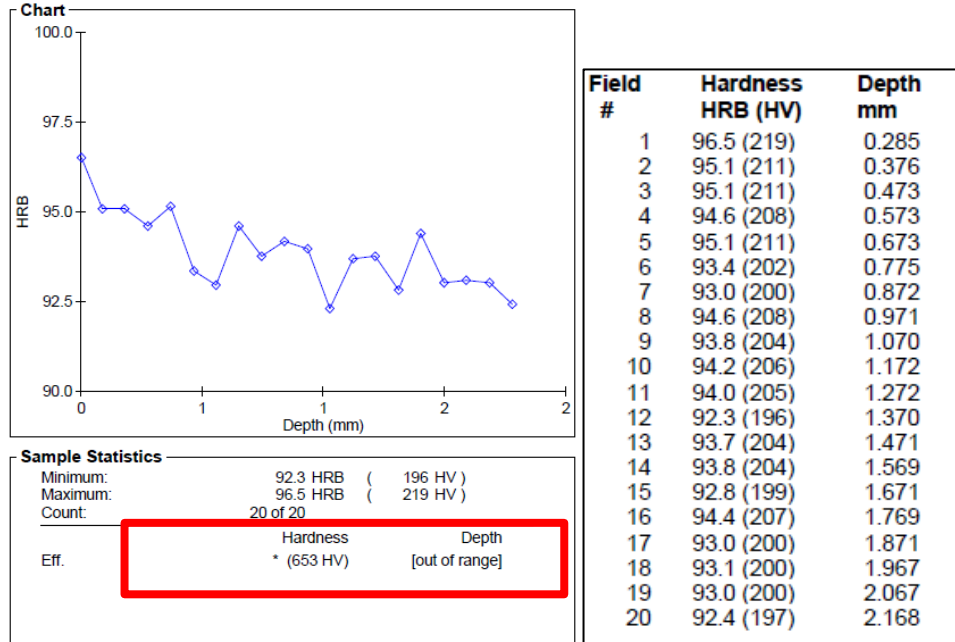
Sample 3-C

The results in this sample show that hardness specifications do not match and confirm the results from the Optical method This is likely due to increased carbon levels at the surface. No hardened case is evident.

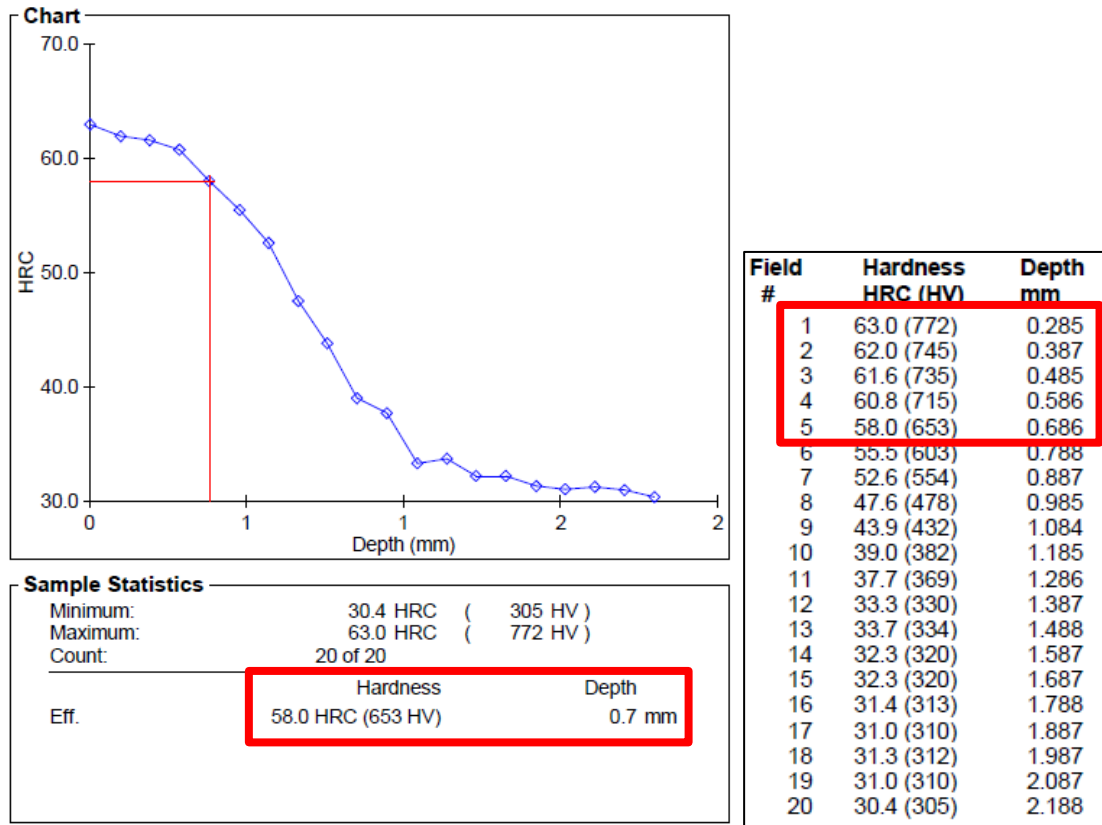
Sample 4-D

KEY FINDING: These are perfect results! The smooth curve of the graph indicates a homogenous microstructure. The hardness and depth results conform to the hardness specifications listed above. The effective case depth results from the Optical results are proven correct.
